IN-TRANSIT CONTROL OF COAL DUST

FROM UNIT TRAINS

Claudio Guarnaschelli, Ph.D., P.Eng.

Report Number EPS 4-PR-77-1

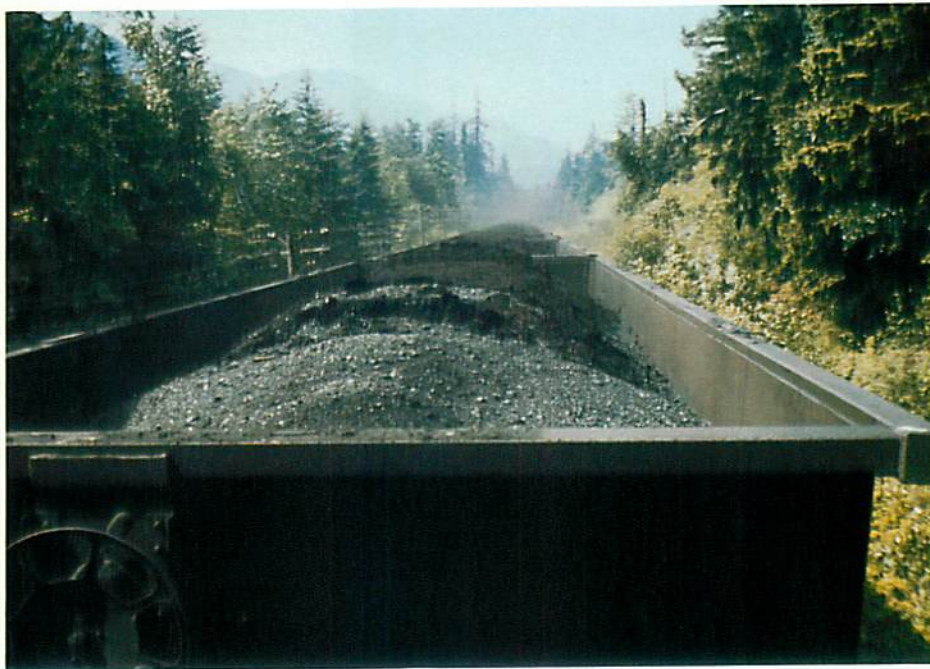
PLATE NO. 1: COAL LOSSES IN TRANSIT

Early in the study it became evident that the loading profile, that is, the geometrical configuration of the exposed surface of the coal, had a large influence on the coal lost in transit (Plate 1). Beshketo<sup>(2)</sup> reported heavy losses of coal at high train speeds. According to his data, the best "hood" height, based on car capacity and winds losses, is 200 mm (8") above the sill of the coal cars (Figure 2). He observed that 6 mm of coal was lost at 60 km/h (40 mph) and 13 mm (1/2") lost at 100 km/h (approx 60 mph). A parallel study on dust losses from mineral concentrates was carried out by Schwartz.<sup>(5)</sup> He observed

Loading profiles had a profound influence on crust retention (Plates 1, 2). A surface particle is affected by the vertical force of gravity and by horizontal forces of linear and centrifugal acceleration

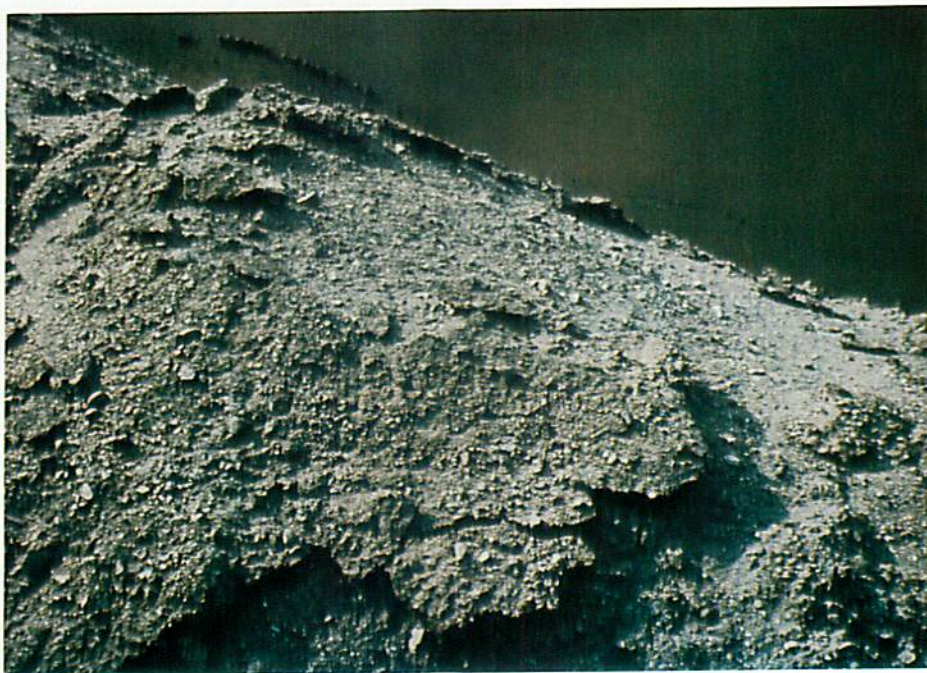
PLATE NO. 2: INCOMPLETE COVERAGE OF SLOPES

tional and torsional movements cracked the surface polymer and patches of polymerized latex were easily removed or displaced by wind (Plate 2). Adherence of the crust to the substrate was minimal, and therefore, the best retention occurred on horizontal surfaces (Plates 10, 11, 12). Because the well polymerized and chemically stable crust of latex products is not water soluble, leaching is unlikely to take place, and therefore, pollution of adjacent water bodies will not occur.

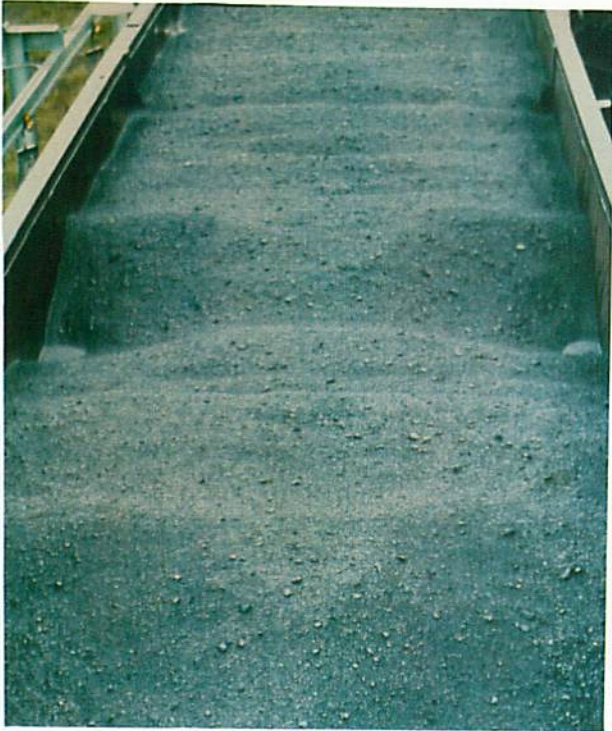
《 PLATE NO.3: UNTREATED  
CAR SHOWING POOLS OF  
WATER AND COARSE COAL

During the field tests it was soon realized that a totally flat surface would produce the most desirable profile (Plates 3, 4). Coverage of the flat portion of the car never presented a serious problem, suggesting that the effects of acceleration and deceleration of the train were negligible compared to the resistance offered by the substrate. The only evidence of failure was the appearance of surface cracks induced by torsional and vibrational stresses to which the cars were subjected during transportation.

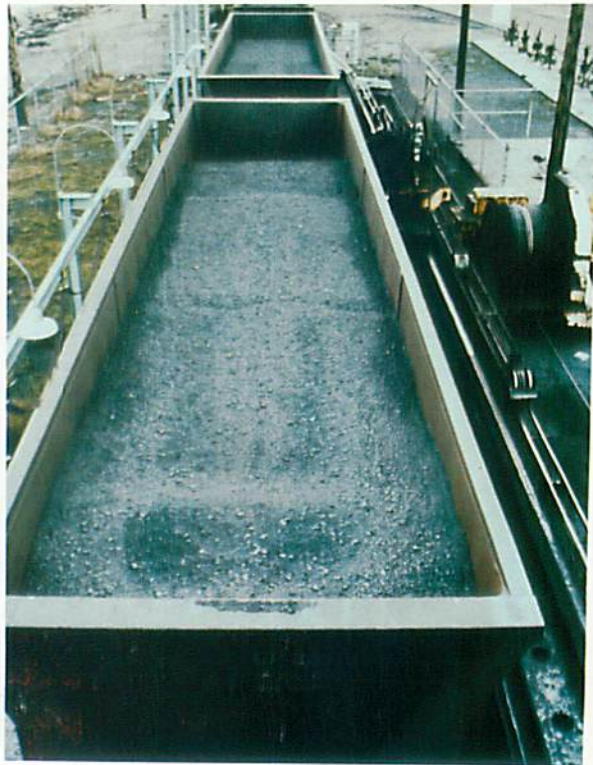
PLATE NO.4:  
PREFERENTIAL WIND  
EROSION OF UNTREATED  
CAR

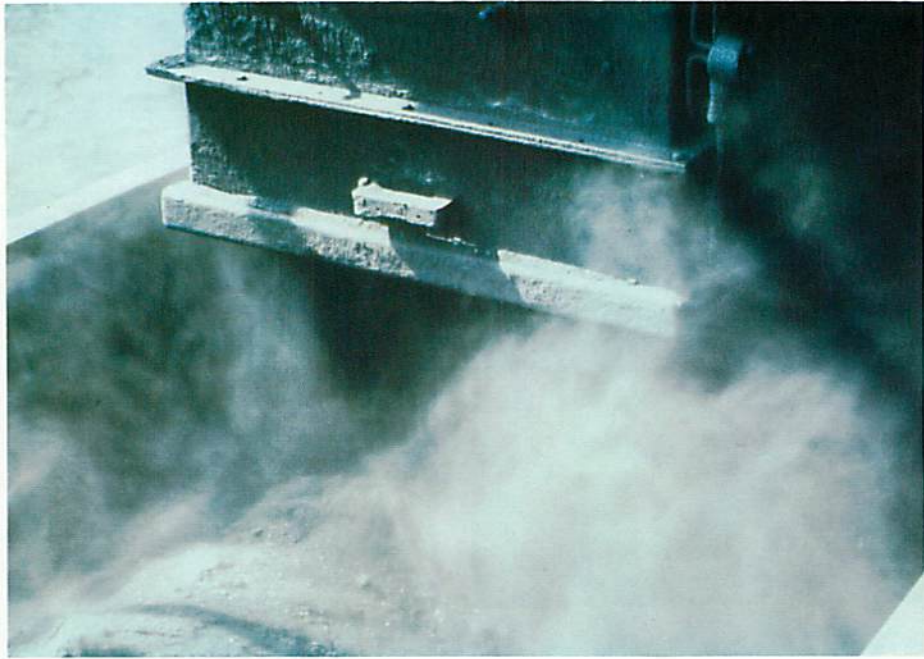
PLATE NO.5: ORIGINAL LOADING METHOD

In practice, the operation of a single loading chute always produced a sloped end at each end of the car (Plates 5, 6). On these slopes, the larger the horizontal component of the opposing force the more stable the system became. At the natural angle of repose where all forces were in balance, any minor disturbance due to acceleration or deceleration of the cars was sufficient to cause failure. To increase crust stability the angle of repose would be decreased at least by the expected maximum acceleration or deceleration of the cars. If this cannot be achieved, then, the strength of the chemical bond within the binder must accommodate the impact of these accelerations plus any torsional or vibrational components.

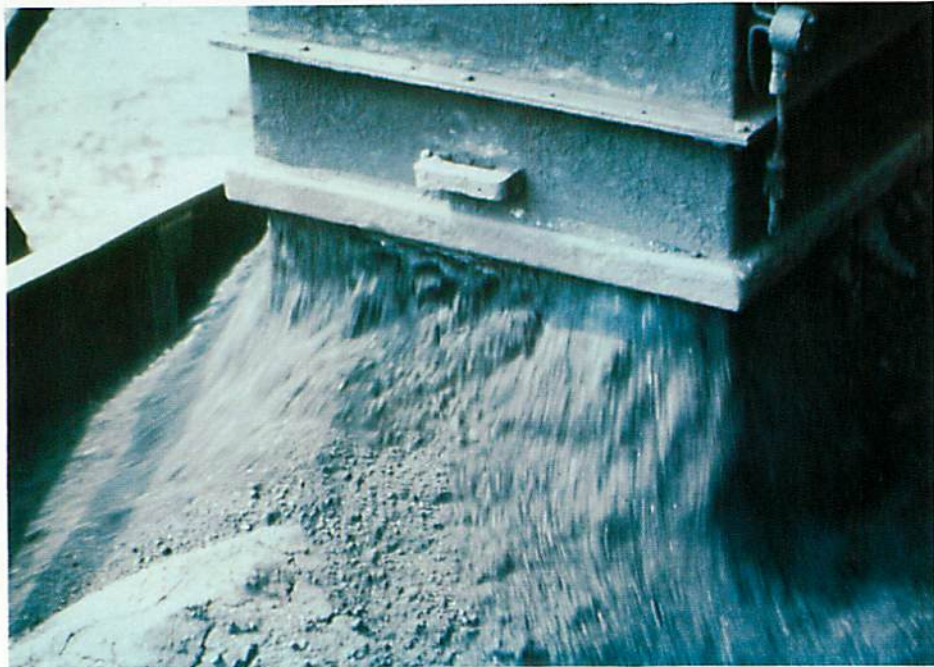
PLATE NO.6: FORMATION OF UNDESIRABLE SLOPES

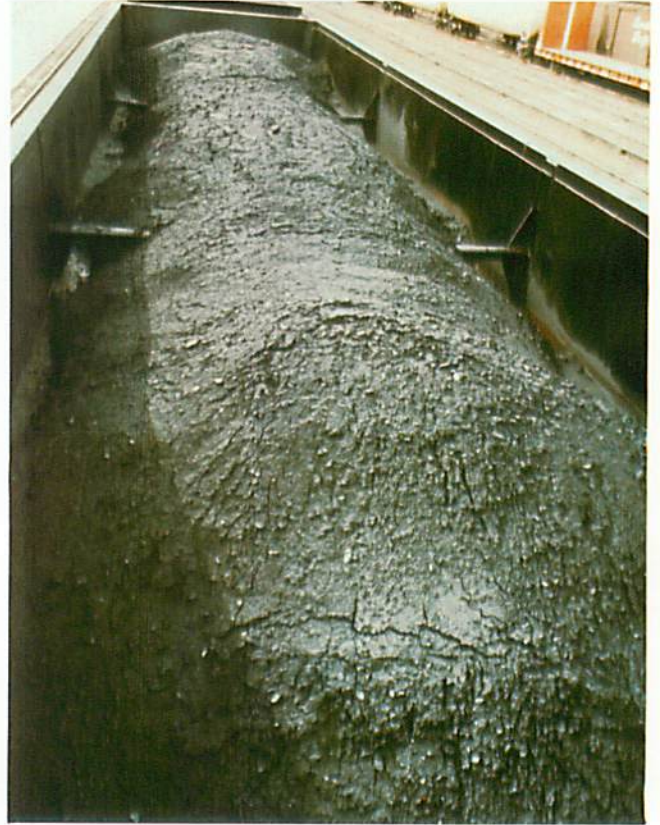
PLATE NO.8: CAR IN PLATE 7  
AT KAMLOOPS

Oil sprays and emulsions were the most effective binders (Plates 7, 8, 9). The success of the binders was attributed to the production of a flexible crust, high viscosity and an inherent ability to regenerate their surface. In other words, the stability of the product prevented the formation of a rigid crust by reacting neither with the coal particles nor with the atmosphere. The cohesive forces of the oil phase were enhanced by the lipophilic character of the coal which facilitated spreading of the oil on the coal surface. In this case the oil-coated particles adhered to each other forming a porous and oozy top layer. The same mechanism was operative in regenerating the top layer of the crust whenever a surface crack was produced by vibrational and/or torsional movement of the cars or by settling of the coal. The oils and emulsions were the only products to display this regenerative property.

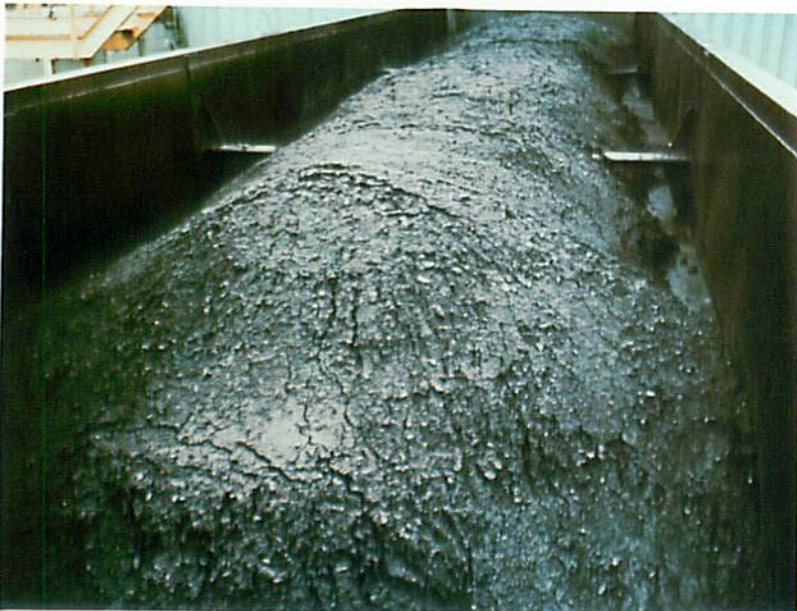
《 PLATE NO.9: CAR IN PLATE 7  
AT WESTSHORE TERMINALS

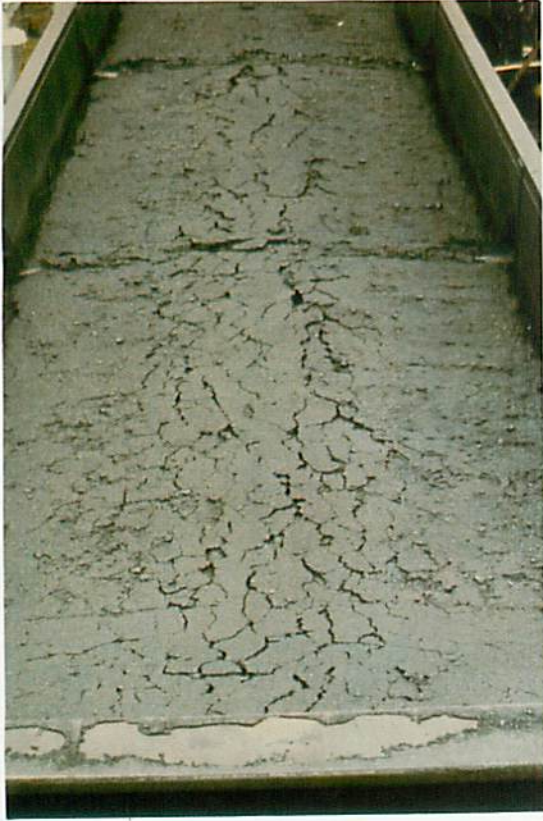
< PLATE NO.10: UNIFORM  
SURFACE COVER

not slump after the application (Plate 10). Coal readily absorbs oils without any prior surface treatment (lipophilic property) but repels water (hydrophobic property). In the case of emulsions, where water is the continuous phase, wetting of the surface can occur only if the surface has been pretreated with a solution containing a surface-active agent, or if there are sufficient quantities of a fast acting surfactant within the formulation.

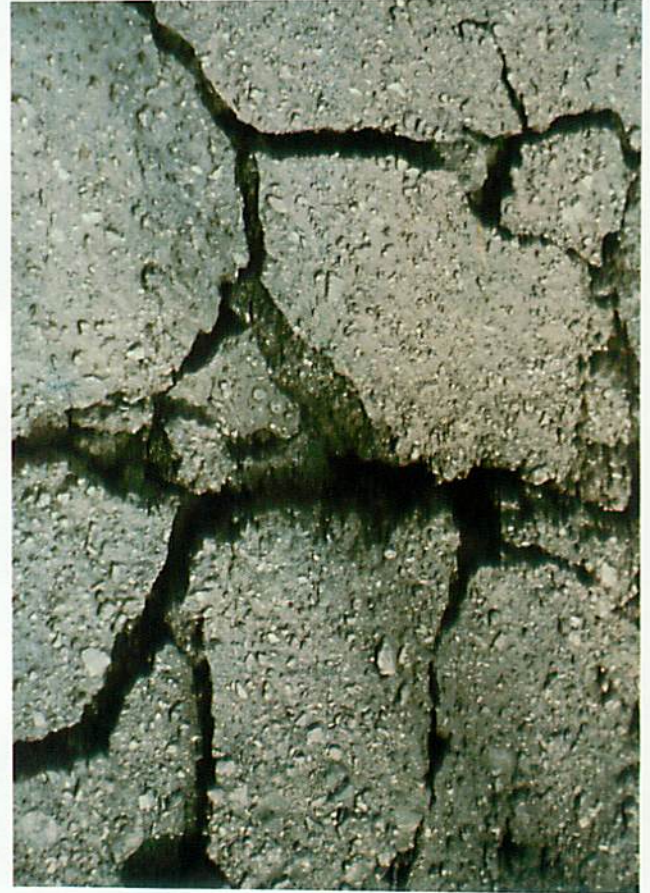
PLATE NO.11: CLOSE-UP  
SHOWING PENETRATION OF BINDER >

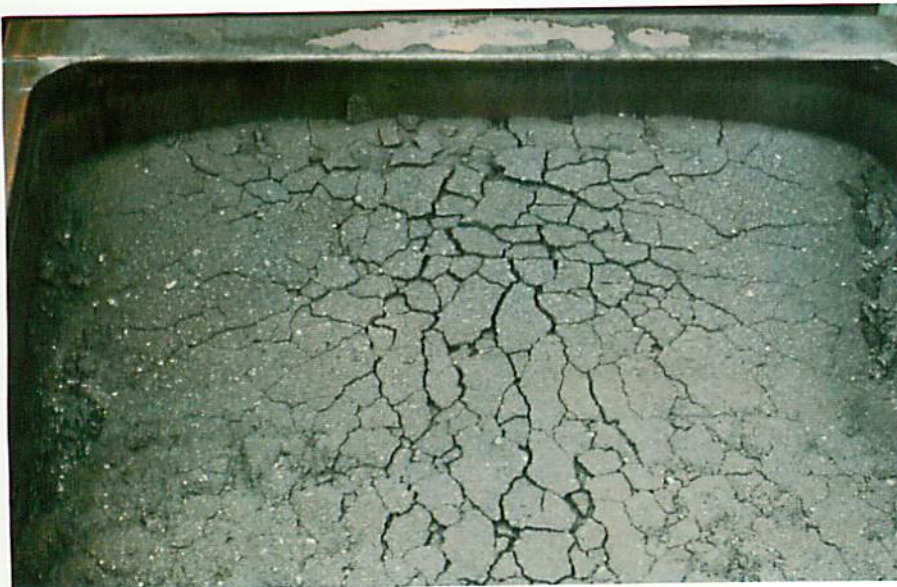
< PLATE NO.12: WELL PRO-  
TECTED FRONT-END SURFACE

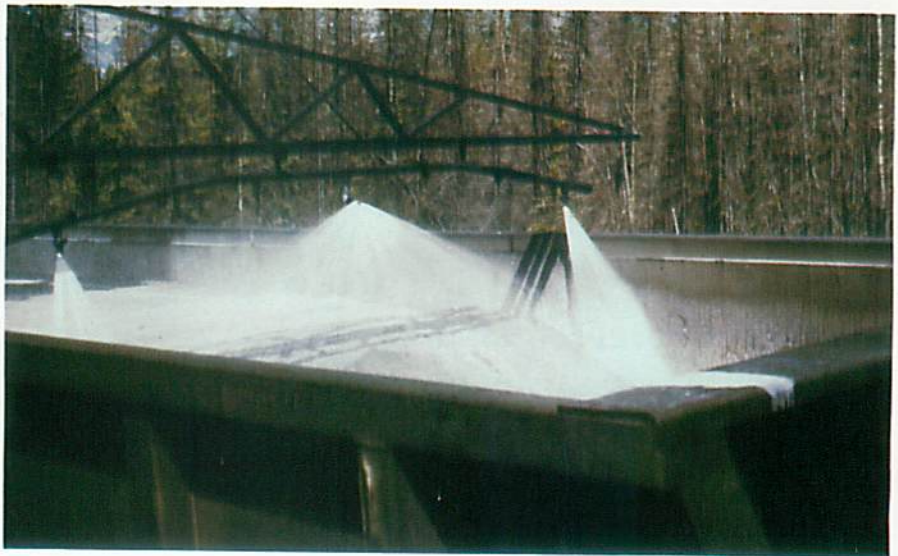
PLATE NO.14:  
END SPRAYING

Preferential spraying is the uneven application of chemical binders to different parts of the exposed surface (Plates 13, 14, 15). The slopes were sprayed more than the horizontal surfaces. This technique has been used with moderate success and will continue to be applied when fast and complete wetting can be achieved without binder run-off.

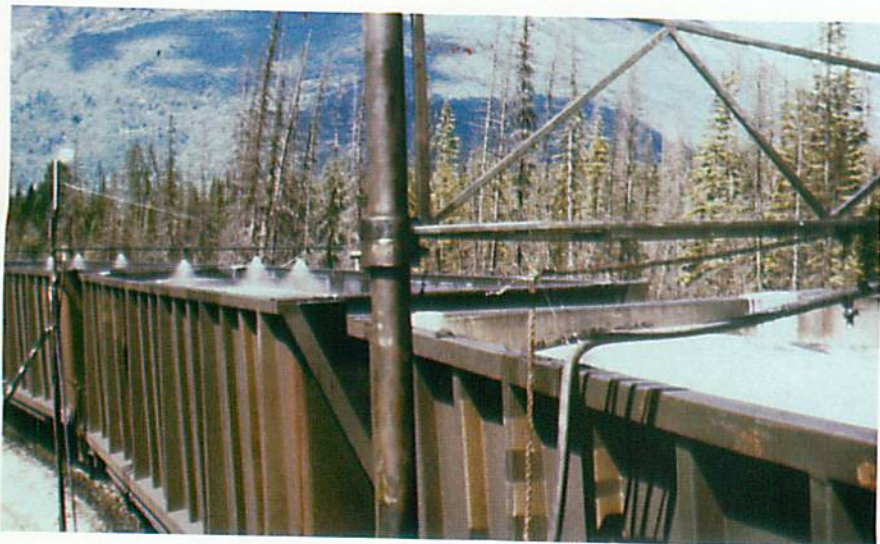
◀ PLATE NO.15: ADDITIONAL  
WATER SPRAYS TO INCREASE  
PENETRATION OF BINDER

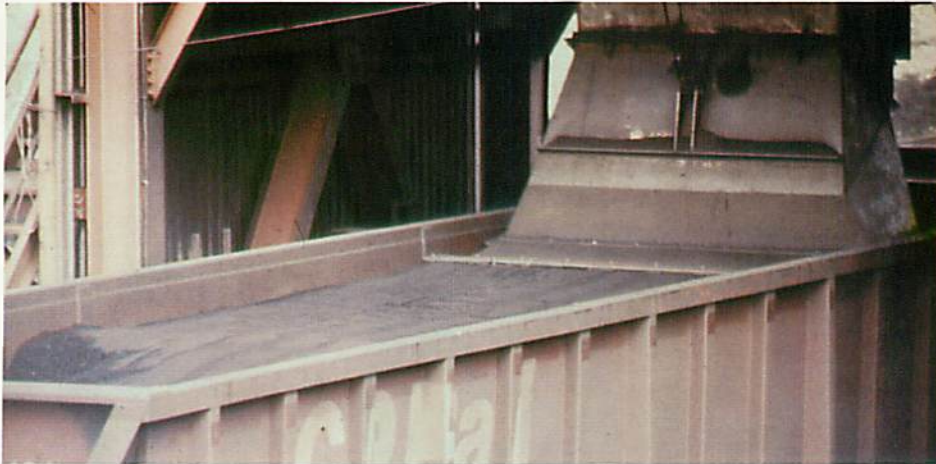
◀ PLATE NO. 16:  
MODIFIED LOADING  
METHOD

New and more capable loading (eg. Plate 16) chutes have improved the loading profile, increased dust control and have reduced considerably the total loading time for the unit train. In addition, the operator can more effectively control the total tonnage carried by each car thus fewer variations in the total carrying capacity occur when cars are loaded to the allowable limit. The net result is a substantial saving of time and money.

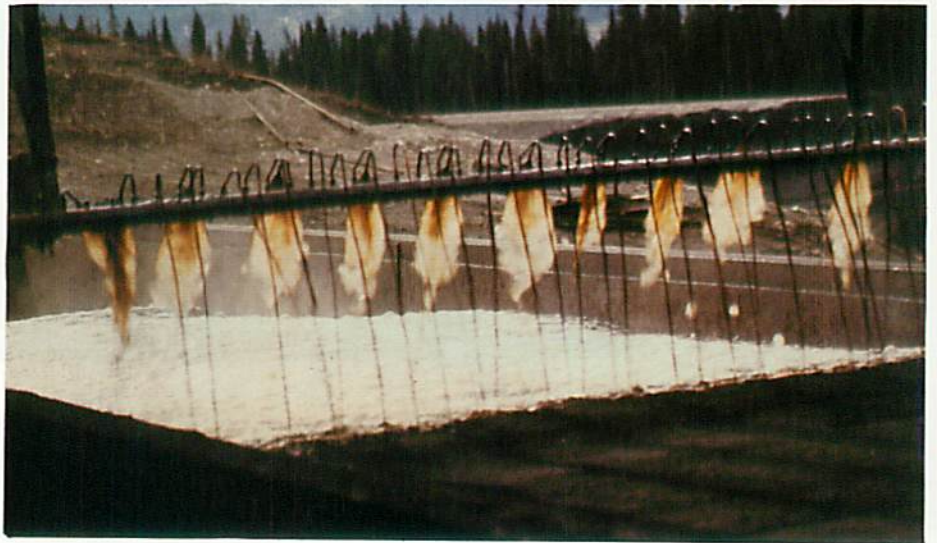
PLATE NO. 17:  
COMBINATION OF  
FLOODING AND  
SPRAYING

To increase binder retention on slopes, Fording Coal Ltd. devised a penetration-spray system designed to achieve not only maximum penetration and thickness but also an adequate surface coverage (Plates 17, 18). The system employs an oscillating spray bar equipped with nozzles capable of open-orifice discharge and fan spraying. The open-orifice discharges are designed to prevent run-off of the emulsion and the formation of a thick crust by increasing binder penetration. The fan sprays are designed to provide a more uniform and adequate coverage of the surface layer. Using this system, Fording Coal Ltd. demonstrated that undesirable slopes could be stabilized almost entirely (Plates 19, 20).

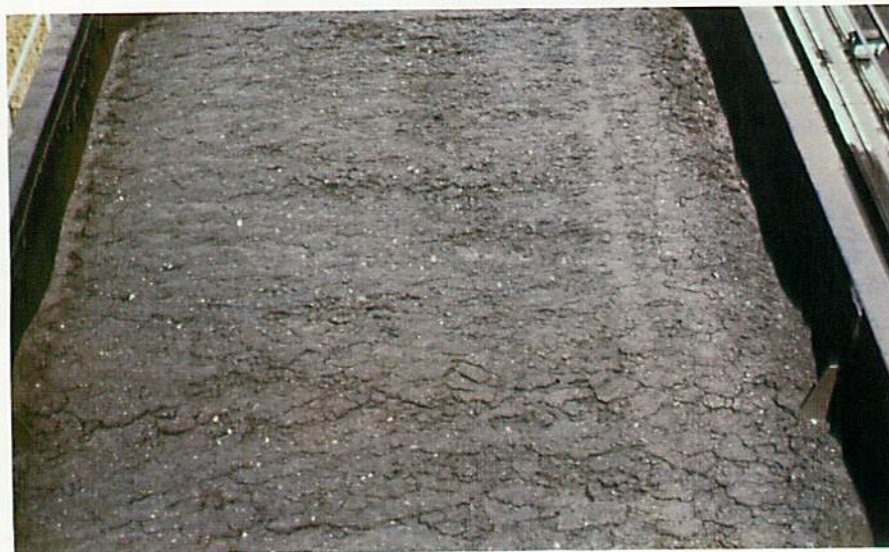
◀ PLATE NO. 18:  
PROPERLY LOADED AND  
SPRAYED SURFACE

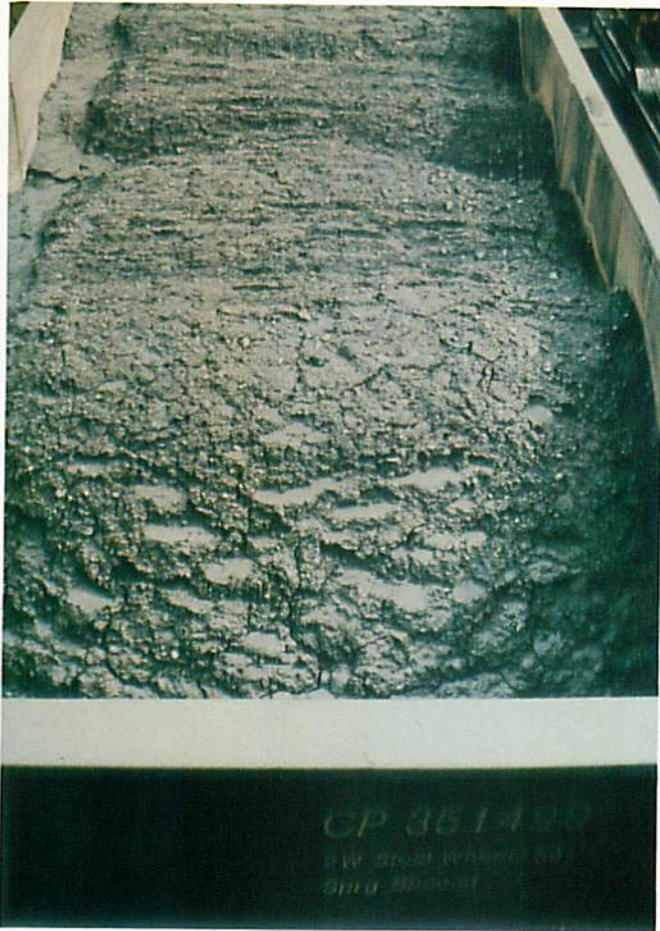
◀ PLATE NO. 19:  
EFFECTIVE SPRAYING  
ON AN UNEVEN PROFILE

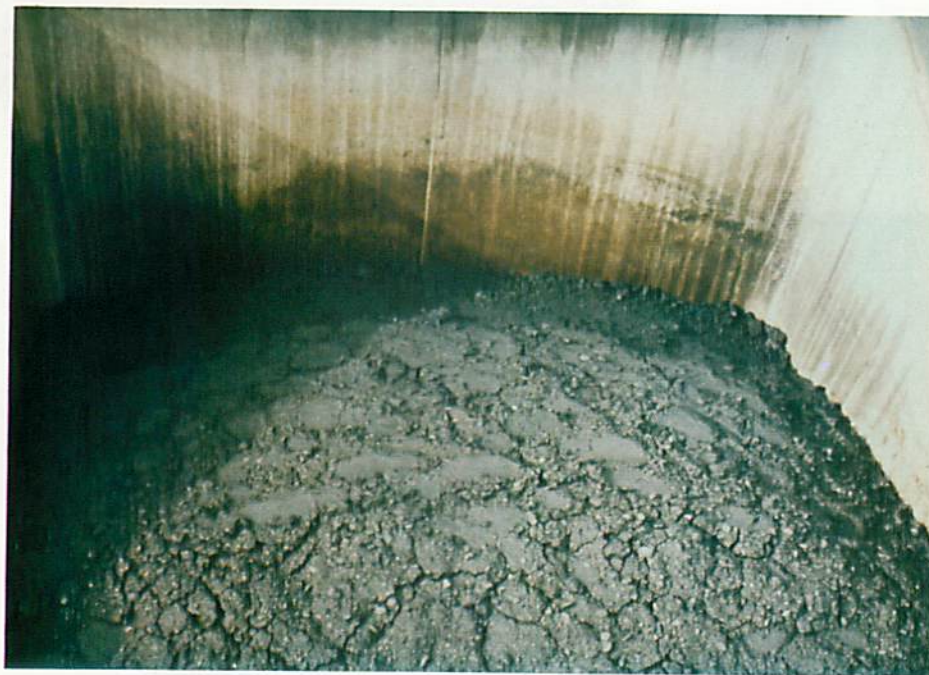
PLATE NO. 20: LIMITED CRUST FAILURE OF SLOPED AREA  
IN CAR IN PLATE 19

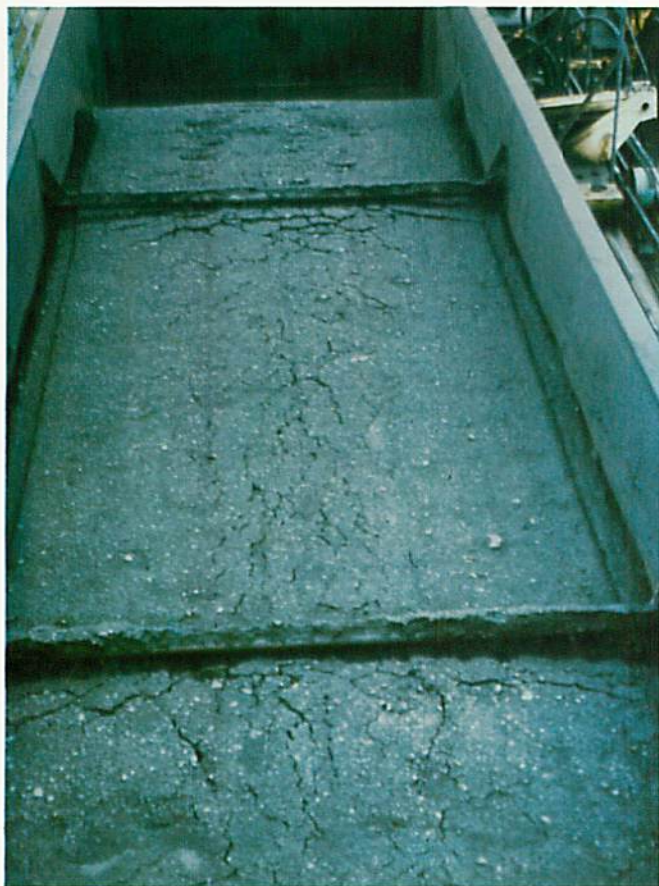
< PLATE 21: SLIDE 434-2  
MINE B  
CAR 349498  
DATE SEPT. 3, 1975  
COVERAGE 95%

In addition, colour photographs were taken of about 220 coal cars. See Plates 21 to 24 for typical photographic recordings.

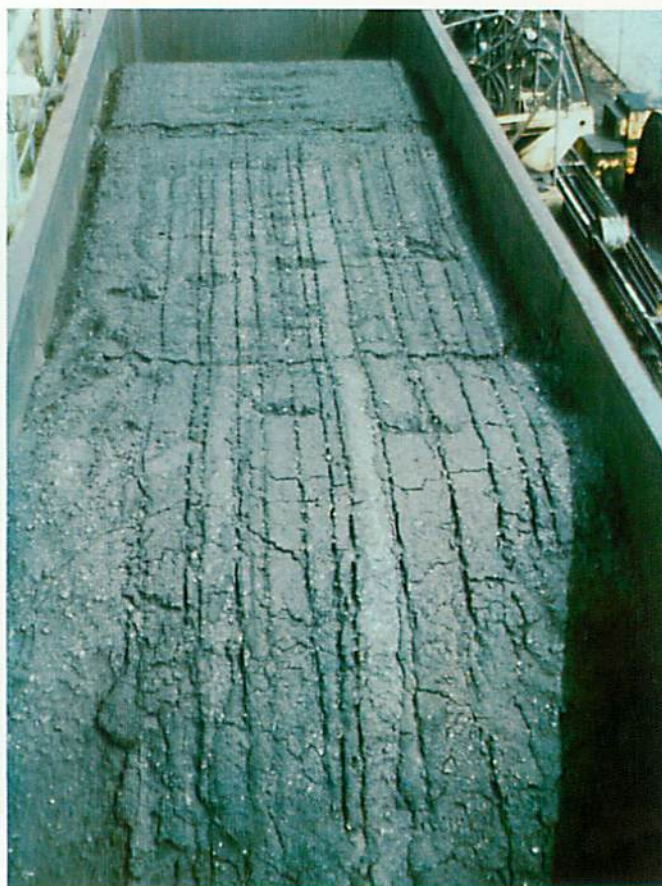
PLATE 22: SLIDE 254-1  
MINE C  
CAR 351620  
DATE Sept. 2, 1975  
COVERAGE 70%

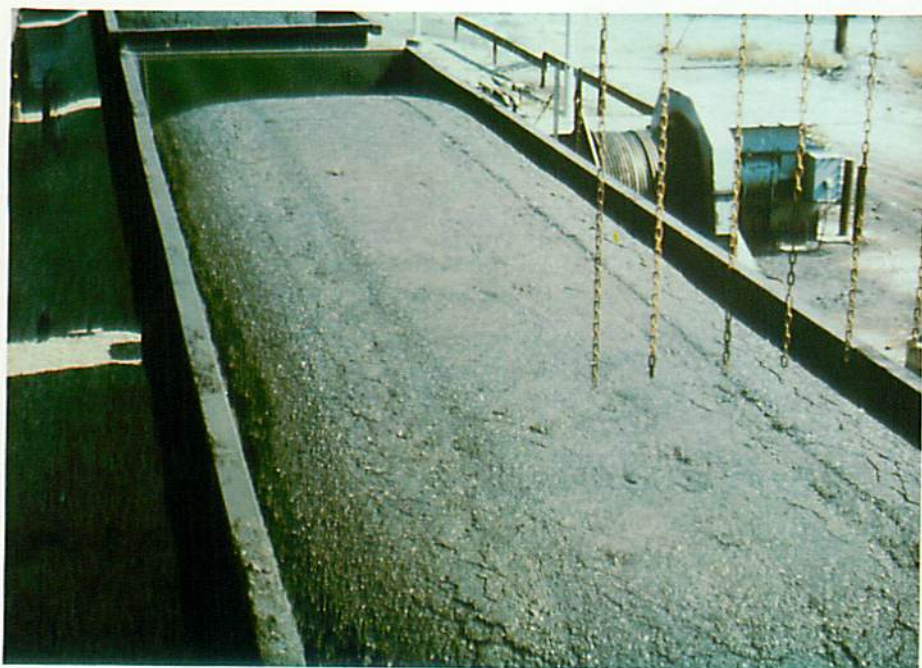
< PLATE 23:  
SLIDE L154-1  
MINE A  
CAR 199013  
DATE SEPT. 3, 1975  
COVERAGE 95%
