Exceeding Tire Speed Rating During Takeoff

By **Ingrid Wakefield**, Flight Operations Engineer; and **Chris Dubuque**, Service Engineer, Landing Gear Systems

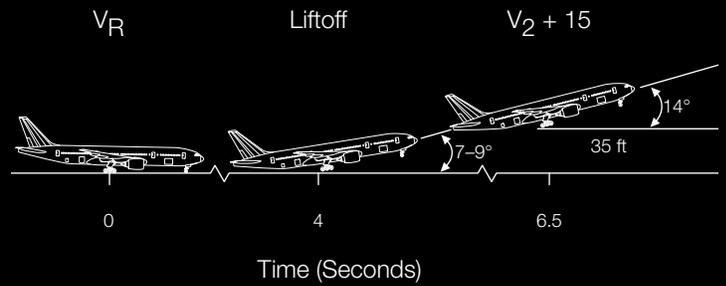
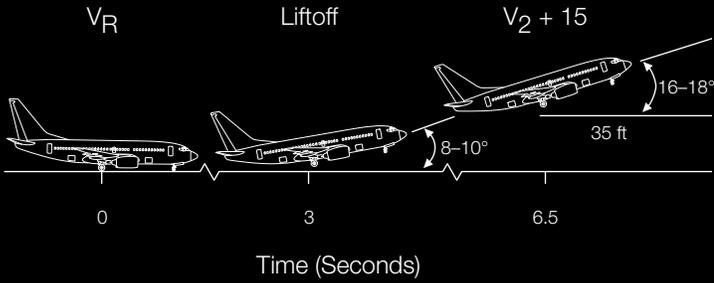
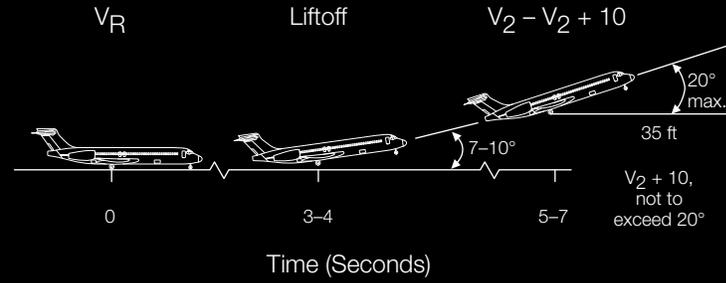
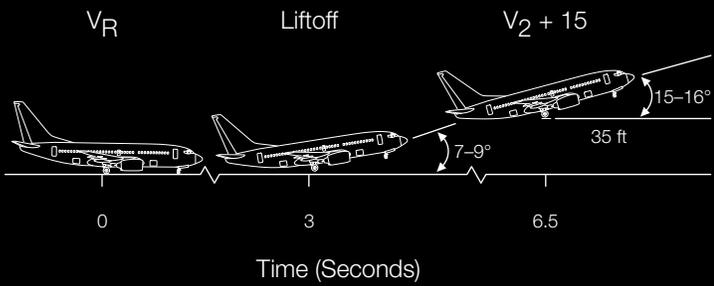
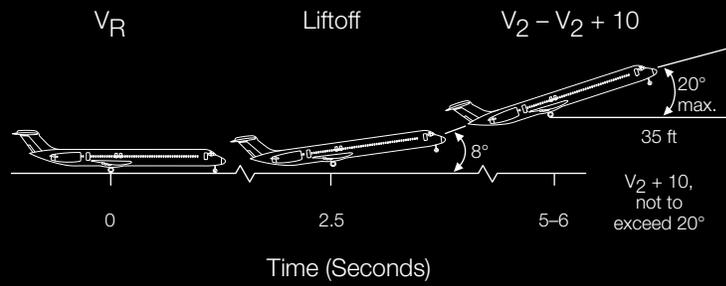
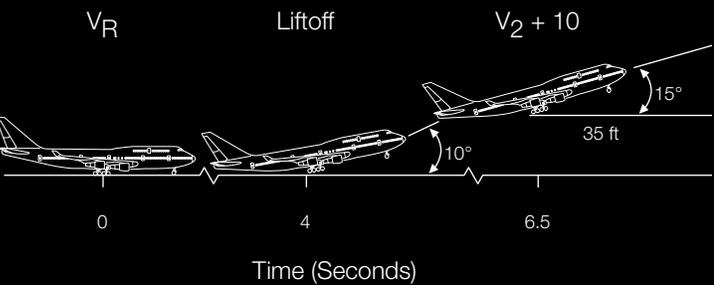
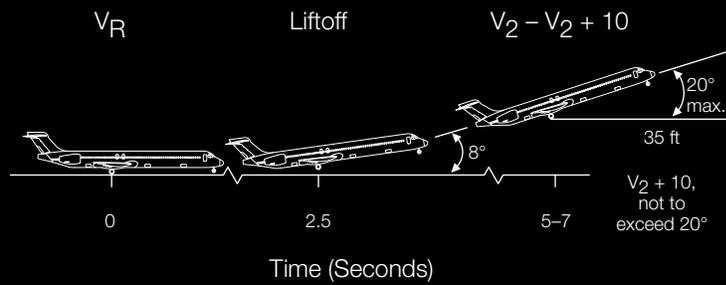
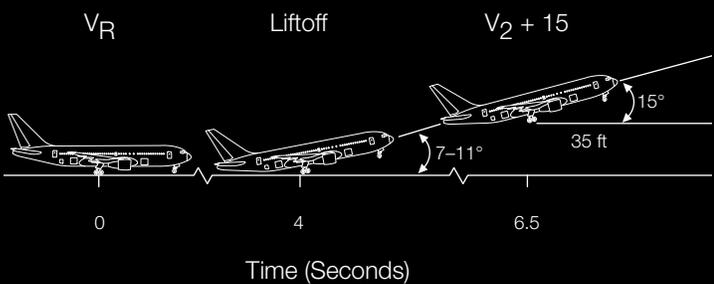
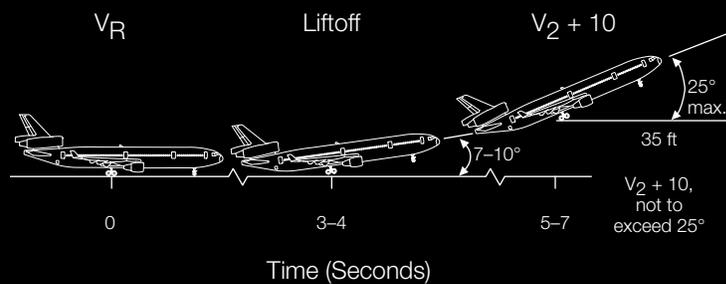
The recommended rotation rate of 2 to 3 degrees per second provides adequate tail clearance margins with a target liftoff attitude reached after approximately 3 to 4 seconds.

777-200 – 777-300ER

737-300/-400/-500

717

737-600 – 737-900ER

MD-80

747-400

MD-90

757-200 – 767-400

Boeing publishes a recommended all-engine normal takeoff procedure in the Flight Crew Training Manual (FCTM) for 727, 737 Classic, and Next-Generation 737, 747, 757, 767 and 777 models and in the Flight Crew Operations Manual for 717, MD, and DC models. In order to avoid tire-speed-limit exceedance during takeoff, Boeing stresses adhering to the recommended average all-engine takeoff rotation rate of 2 to 3 degrees per second, which provides adequate tail clearance margins with a target liftoff attitude reached after approximately 3 to 4 seconds (see fig. 1).

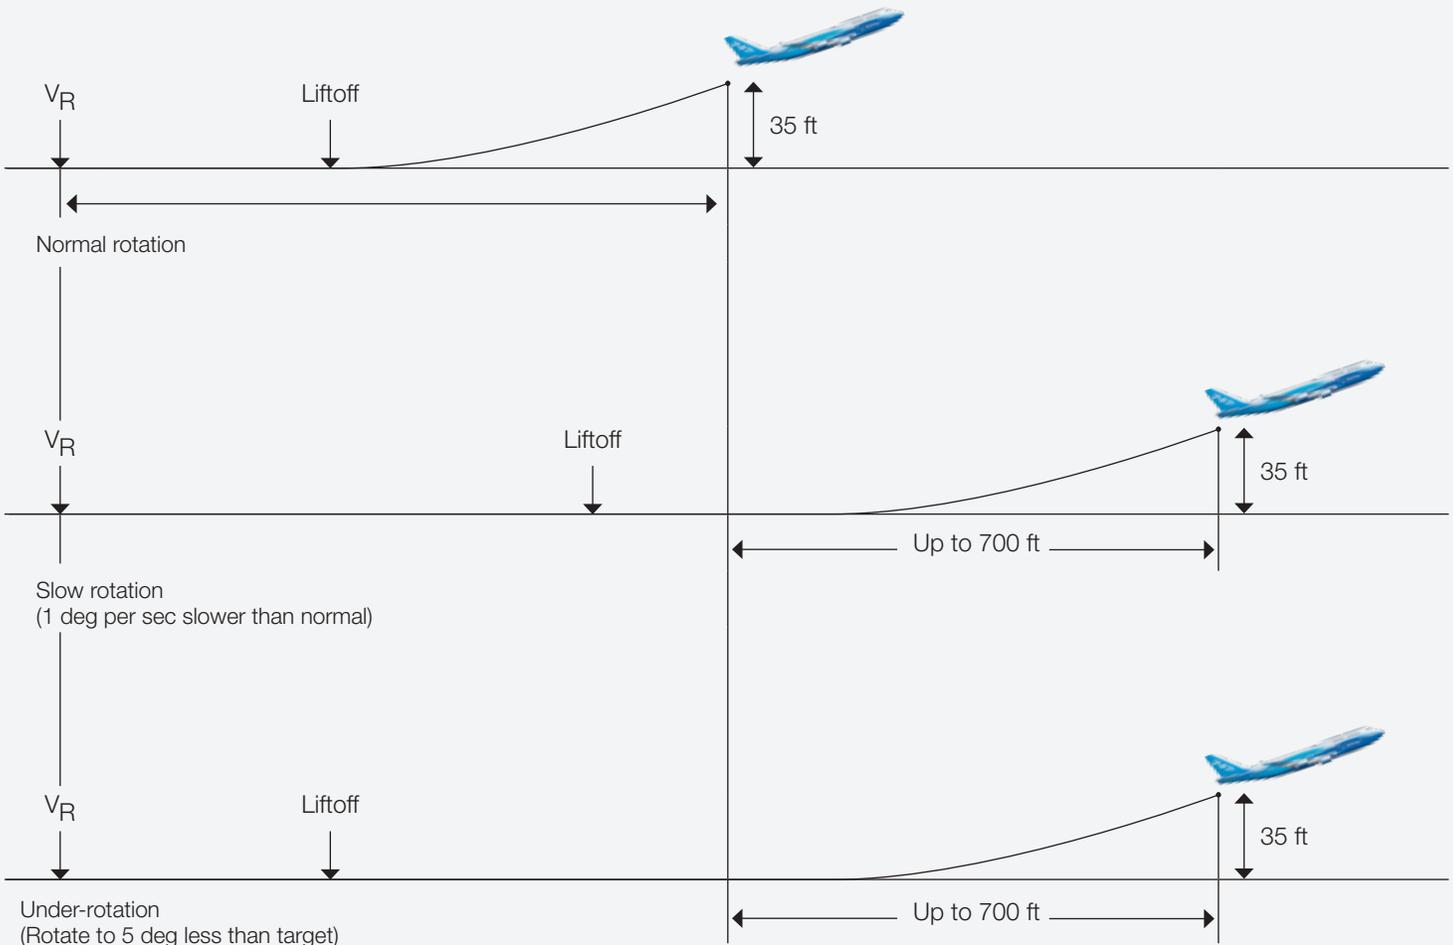
Figure 3: Effect of slow or under-rotation on all-engine takeoff distance

A 747-400 taking off with a rotation rate that is 1 degree per second slower than normal can result in a 4- to 5-knot liftoff speed increase.

The same case study showed that a rotation rate that is 1 degree per second slower than normal can result in a 4- to 5-knot liftoff speed increase. This is in addition to the increase in all-engine takeoff distance associated with the slow takeoff rotation (see fig. 3).
